Storm Drain Rehabilitation Project Corrective Action Plan (CAP) – Final Submittal Technical Memorandum (City Project PW 1501-2015)

City of Casselberry, FL

Singhofen & Associates, Inc.
Stormwater Management and Civil Engineering

June 2016

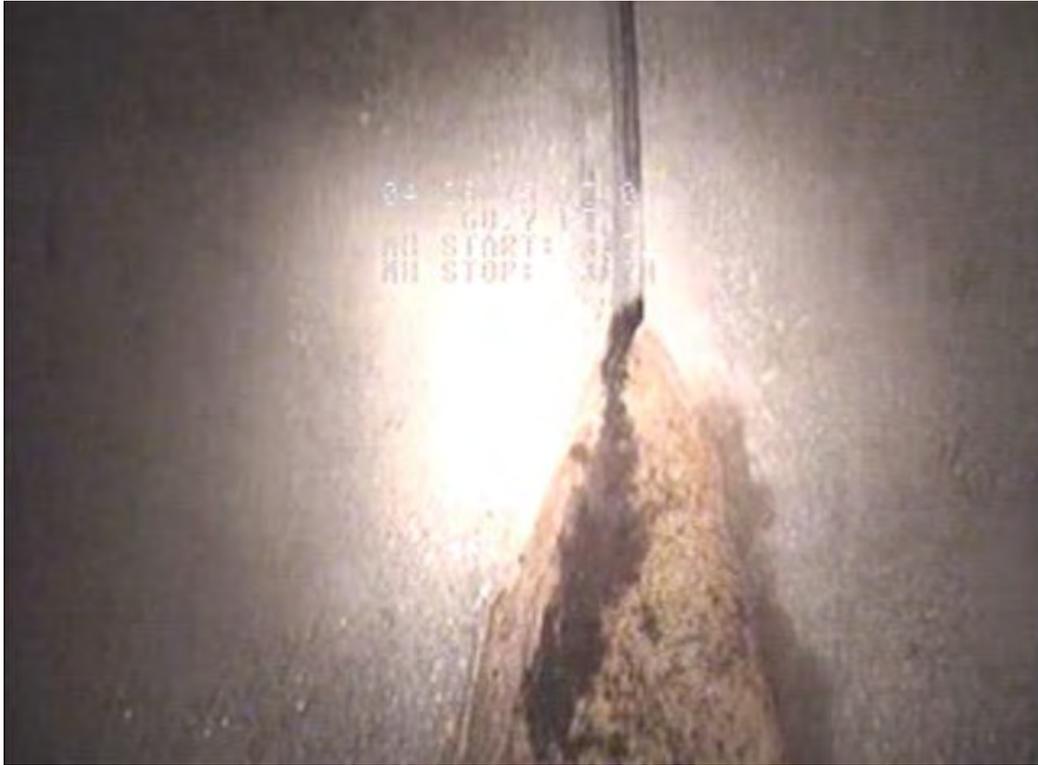
Figure 3.2 - Area A: Mineral Stain (Culvert #317 - #317N)

Area A is located along Kantor Boulevard and also includes the culvert behind the residences parallel to Holtz Drive between Kantor Boulevard and Stanhope Drive (**Figure 3.1**). This area consists of 5 culvert segments that were inspected by Altair. Deficiencies were identified in 4 of the culverts. There are two locations with mineral stains in the culvert located between structures #317 and 317N. The presence of mineral stains are indicative of leakage at the joint. The culvert between structures #317 and #103 included multiple instances of root intrusion. Root intrusion was also found in the culvert between structures #315 and #115. Furthermore, this culvert included a severe amount of concrete throughout the majority of the pipe. It is likely a person will need to enter the 48" pipe and manually break out the concrete in order to remove it before the recommended CIPP can be implemented. Examples of the issues observed are presented in **Figures 3.2** through **3.5**. Improvements for this area include CIPP and chemical grout.

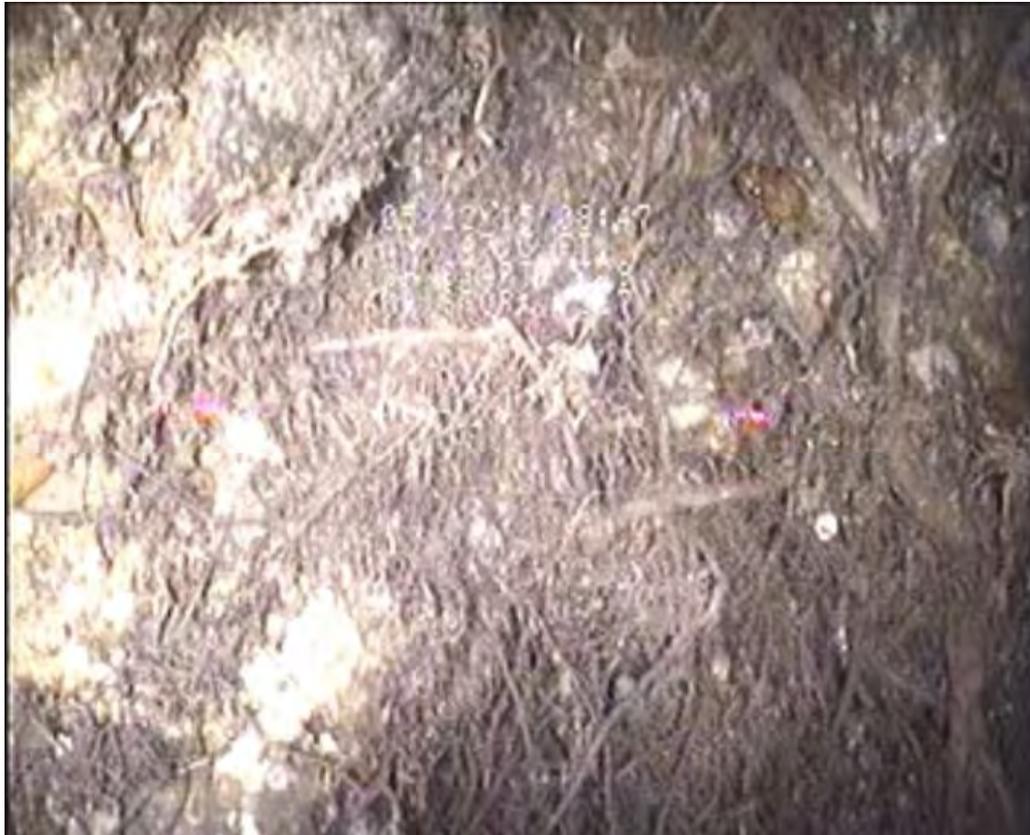
Figure 3.3 - Area A: Root Intrusion (Culvert #317 - #329)

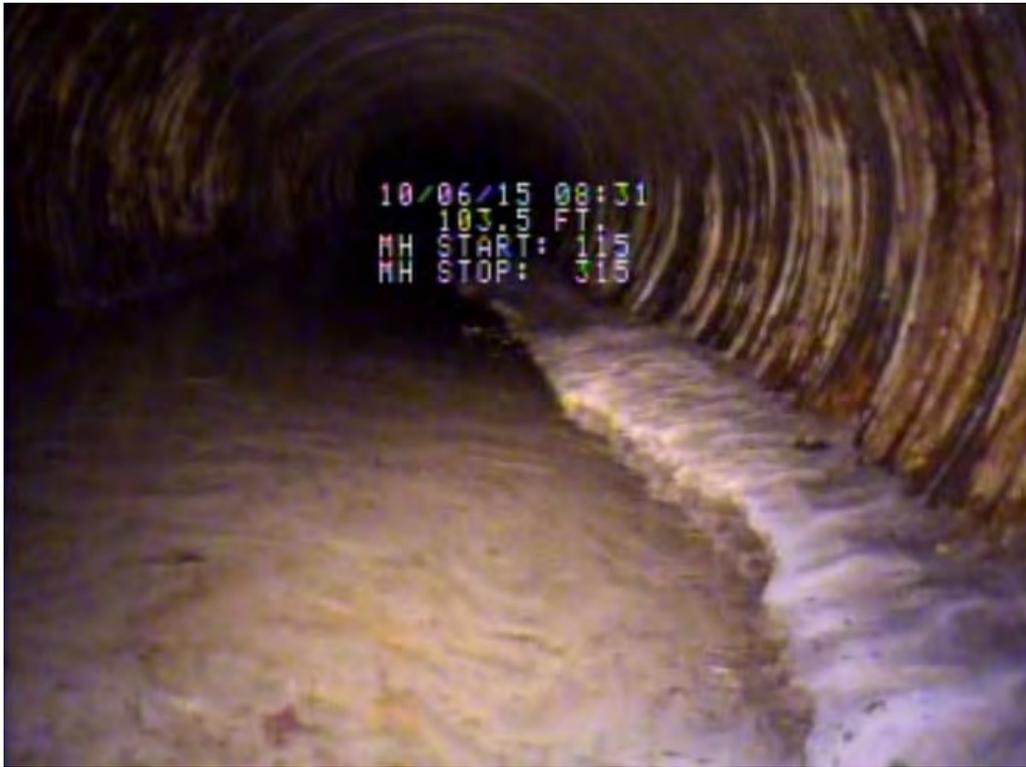
Figure 3.4 - Area A: Cement in Pipe (Culvert #115 - #315)

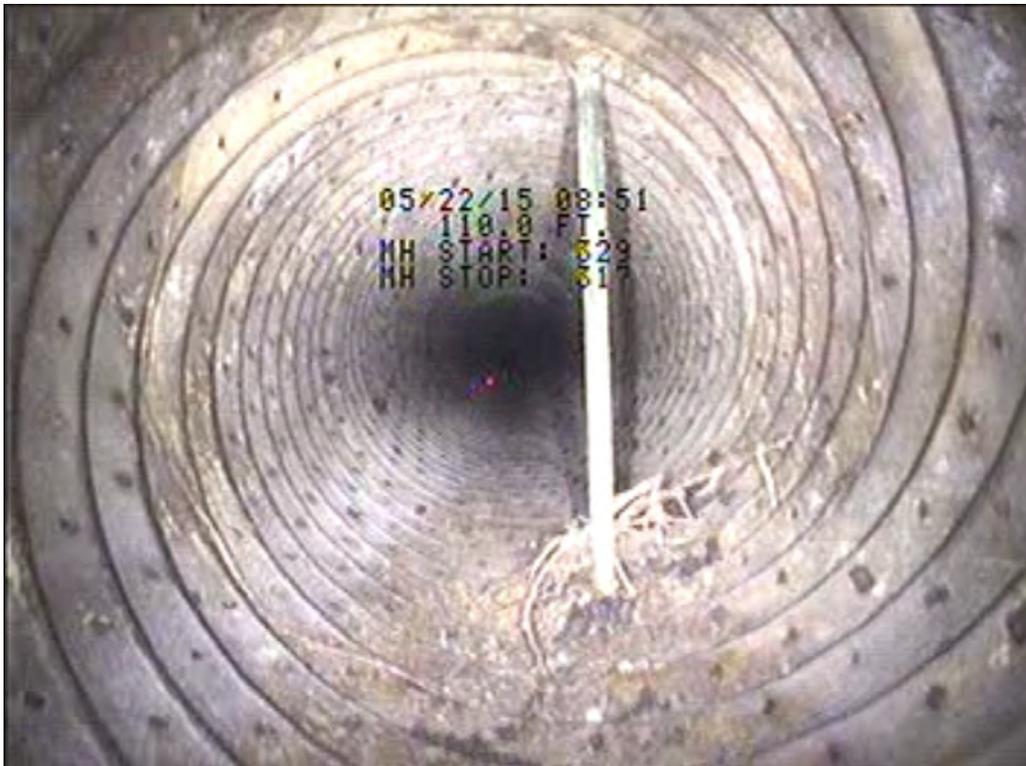
There is also a location along the culvert between structures #317 and #329 where there is an unidentified rod protruding through the storm pipe. While this is not noted as a structural issue, the CCTV camera was not able to traverse beyond the rod. Recommended improvements for this culvert include placing CIPP throughout the culvert from both the upstream and downstream inlets. Chemical grout will also be placed at the location of the rod conflict. The camera was thus run from both ends of the pipes in order to evaluate the entire culvert length.

Figure 3.5 - Area A: Rod Protruding through Pipe (Culvert #317 - #329)

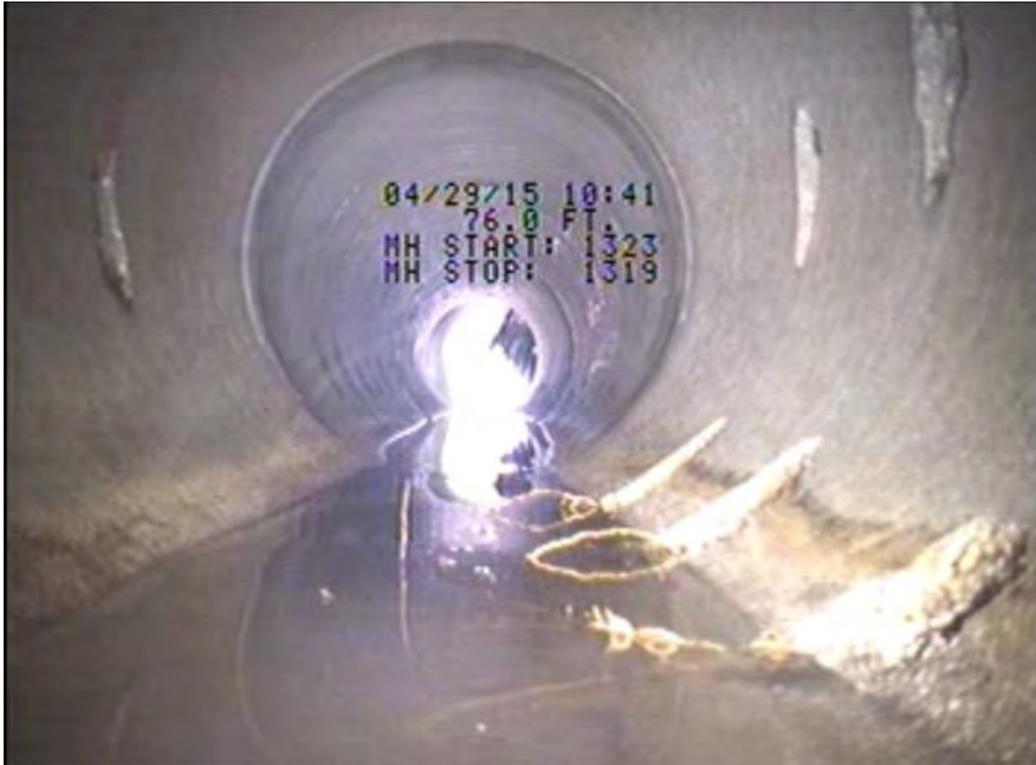
Figure 3.7 - Area C: Roots in Slotted Pipe (Culvert #1323 - #1319)

Area C is located along Quintuplet Drive and is broken down into 5 sub-areas (C1 through C5) (Figure 3.6). This area consists of 26 culvert segments that were inspected with CCTV by Altair. Deficiencies were identified in 13 of the culverts. The majority of the issues were related to root intrusion. Two culverts were found to be perforated concrete pipes which had multiple locations where roots were growing through the slots in the pipes (between #1323 and #1319 and between #1147 and #1161). There were several other locations where cracks in the pipe or joint separations were identified.

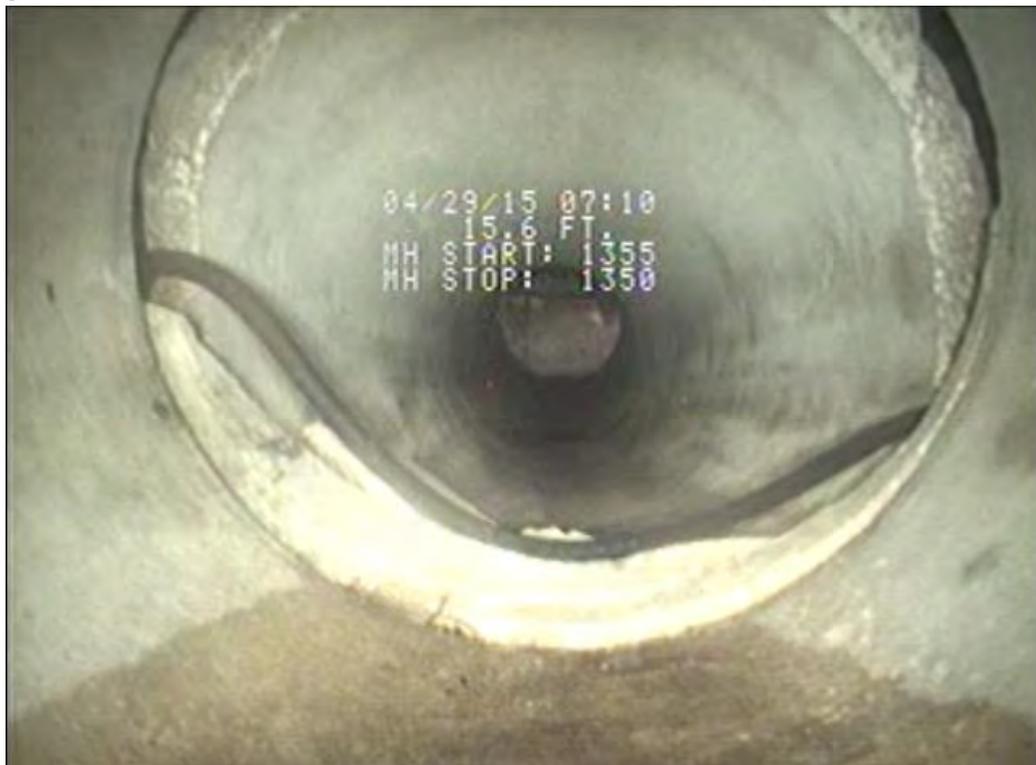
Figure 3.8 - Area C: Broken Gasket and Pipe Separation (Culvert #1350 - #1355)

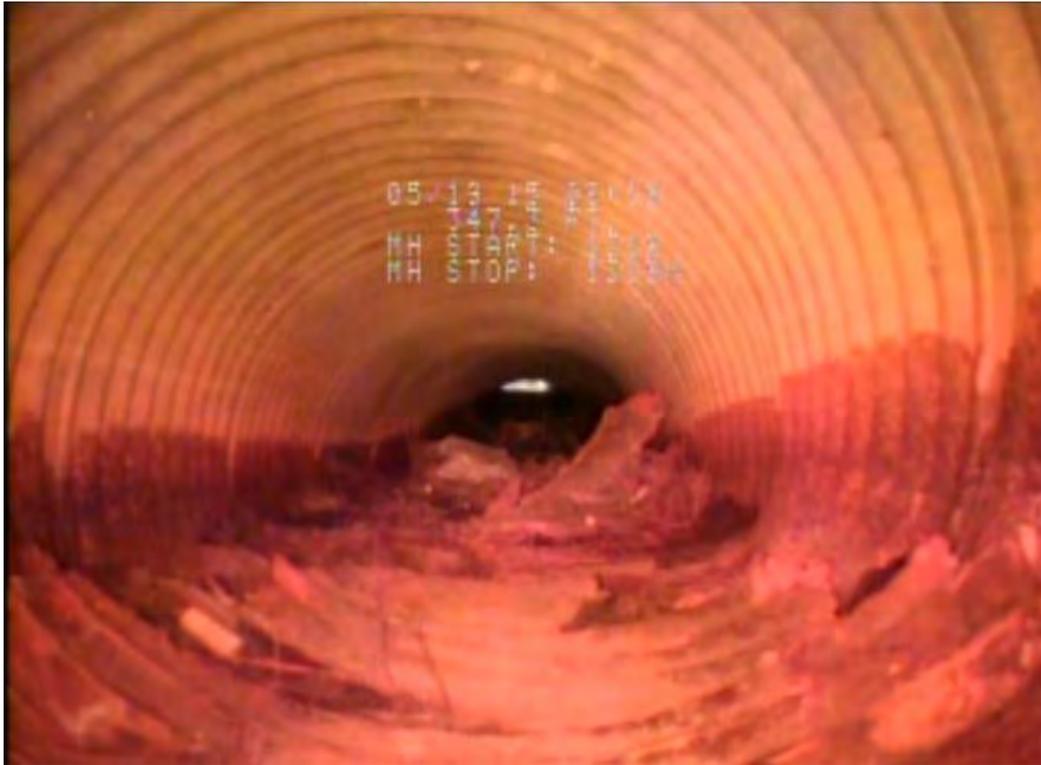
Due to heavy deterioration and breaks in the pipe, CCTV inspection could not be completed for the full length of the culvert between structures #1319 to #1319N. As a result of the pipe breaks, there is also heavy debris located within the pipe approximately 350' downstream. The camera was unable to pass this location, nor was there a sufficient location at the other end of the culvert in order to set up the camera and run it from the other end. The recommended rehabilitation at this location is to remove and replace the culvert with the same size (24") RCP. Heavy sedimentation was also noted in the culvert between #1109 and #1107. Examples of the issues observed are presented in Figures 3.7 through 3.9. Recommended improvements at this location included removing the sediment and debris from the pipe.

Figure 3.9 - Area C: Broken Pipe with Debris (Culvert #1319 - #1319N)

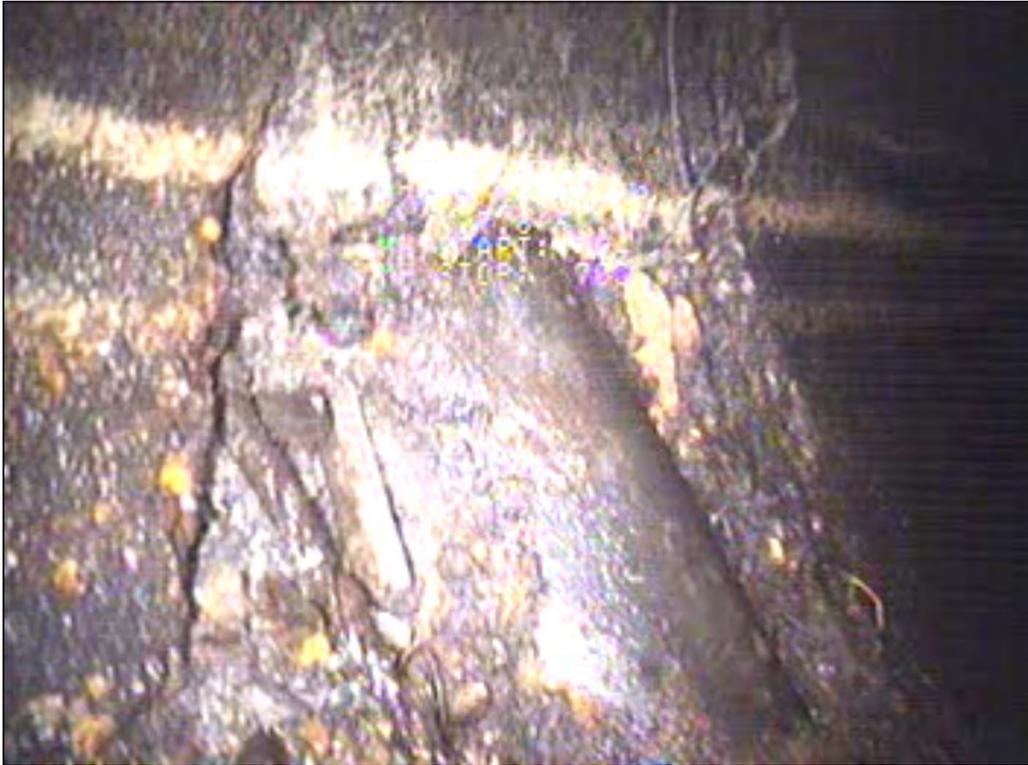
Area D is located along Gregory Drive and is shown on **Figure 3.10** below. This area consists of 6 culverts that were inspected with CCTV by Altair. Only one culvert was found to require rehabilitation. There is a chip/hole in the culvert located between structures #704 and #703 that will require CIPP. The chip is large enough that another pipe is visible through the hole that has been created. Another culvert was found to have a conflict where a sanitary pipe runs through the top of the storm pipe, however there were no signs of leaks or breaks at this location. Examples of the issues observed are presented in **Figures 3.11** and **3.12**.

Figure 3.11 - Area D: Hole in Pipe (Culvert #704 - #703)

The total estimated construction cost for this area is \$9,400 for the CIPP. A detailed breakdown of the cost estimate is included in **Table 3.4**.

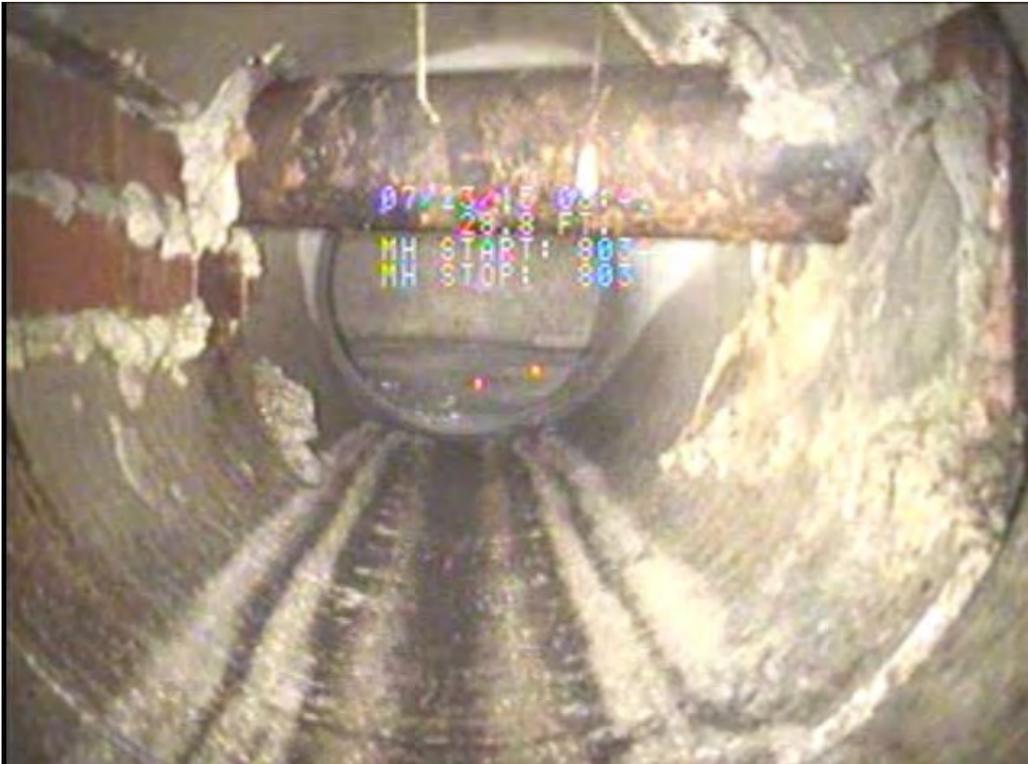
Figure 3.12 - Area D: Sanitary Pipe Conflict (Culvert #803A - #803)

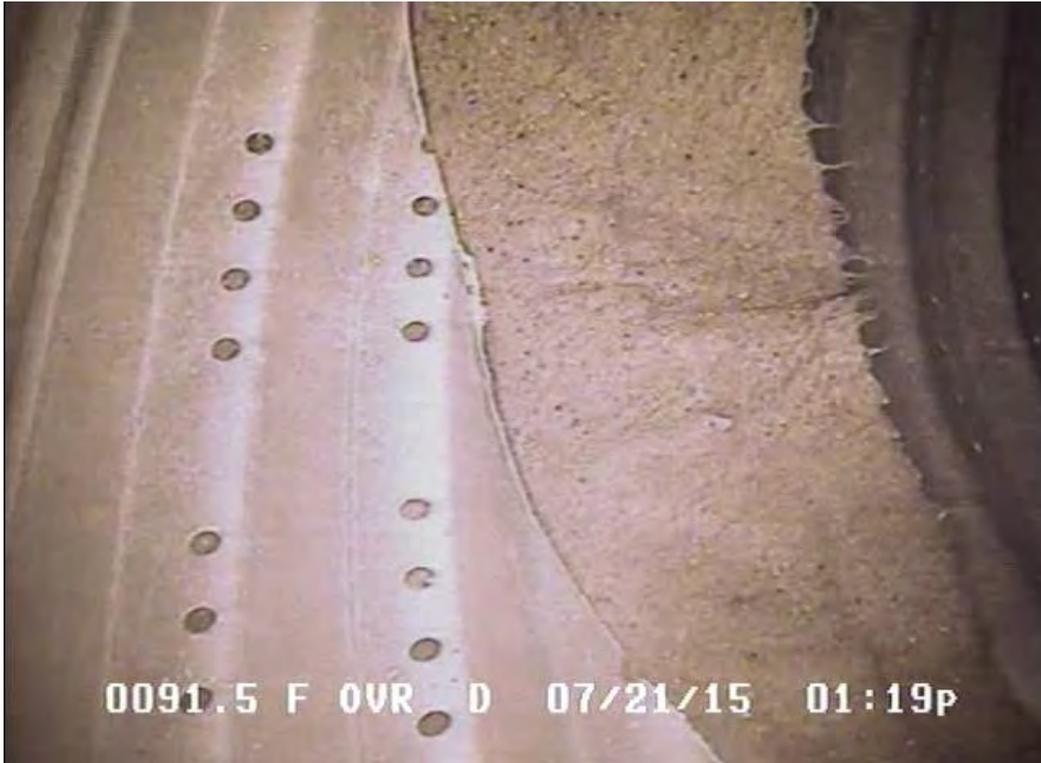
Figure 3.14 - Area E: Break in CMP (Culvert #196 - #130)

Area E is located along Concord Drive at the intersection with Cypress Way (**Figure 3.13**). CCTV inspection was performed on two culverts in this area. Deficiencies were identified in both culverts, one of which is extensive enough that it is recommended to be replaced. A crack was found in the 18" RCP that crosses Cypress Way (structures #196 to #200) which will need to be grouted. The culvert from structures #196 to #130 included numerous roots throughout culvert as well as breaks in the CMP. The first 90' of the pipe is perforated CMP, however, the remaining 169' are standard, non-perforated CMP. Furthermore, the joint where the pipe becomes non-perforated has a large break/tear in the CMP that has exposed the filter fabric. There are additional locations where the culvert is broken and/or rusted out throughout the culvert. Examples of the issues observed are presented in **Figures 3.14** and **3.15**. At the request of the City, suggested improvements from #196 to #300 have been eliminated from this design. It is understood that improvements to this segment of pipe are to be incorporated into plans for Concord Drive to be prepared by others. The estimated construction cost for the remaining improvements for this area is \$4,100. A detailed breakdown of the cost estimate is included in **Table 3.5**.

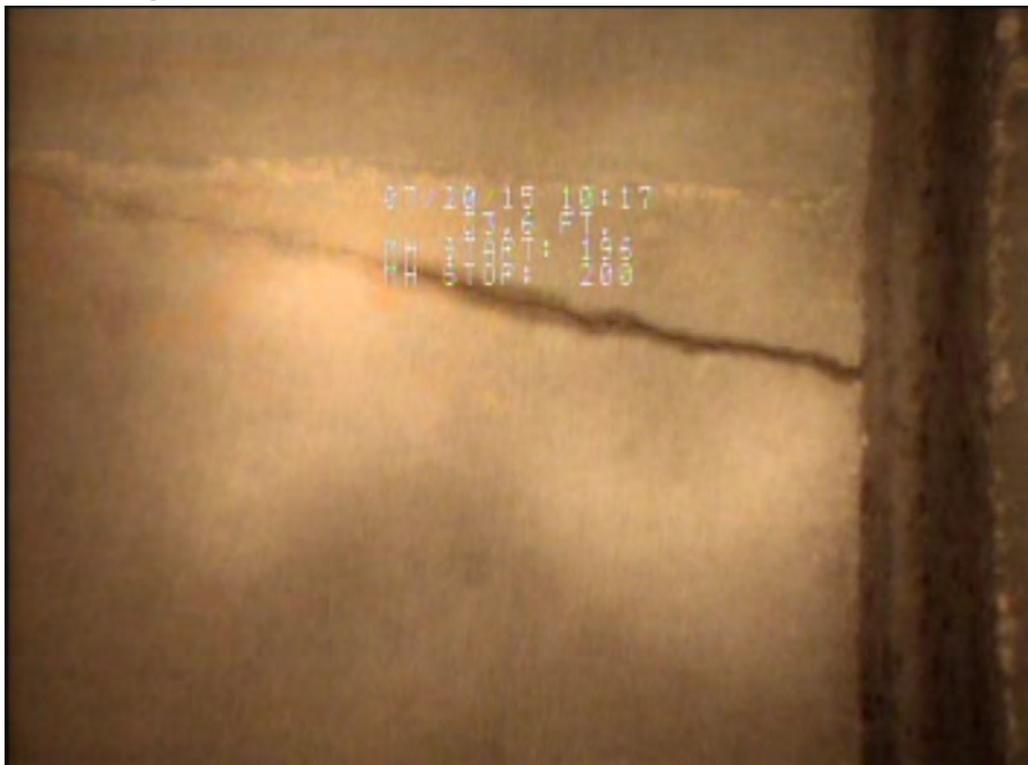
Figure 3.15 - Area E: Crack in Culvert (Culvert #196 - #130)

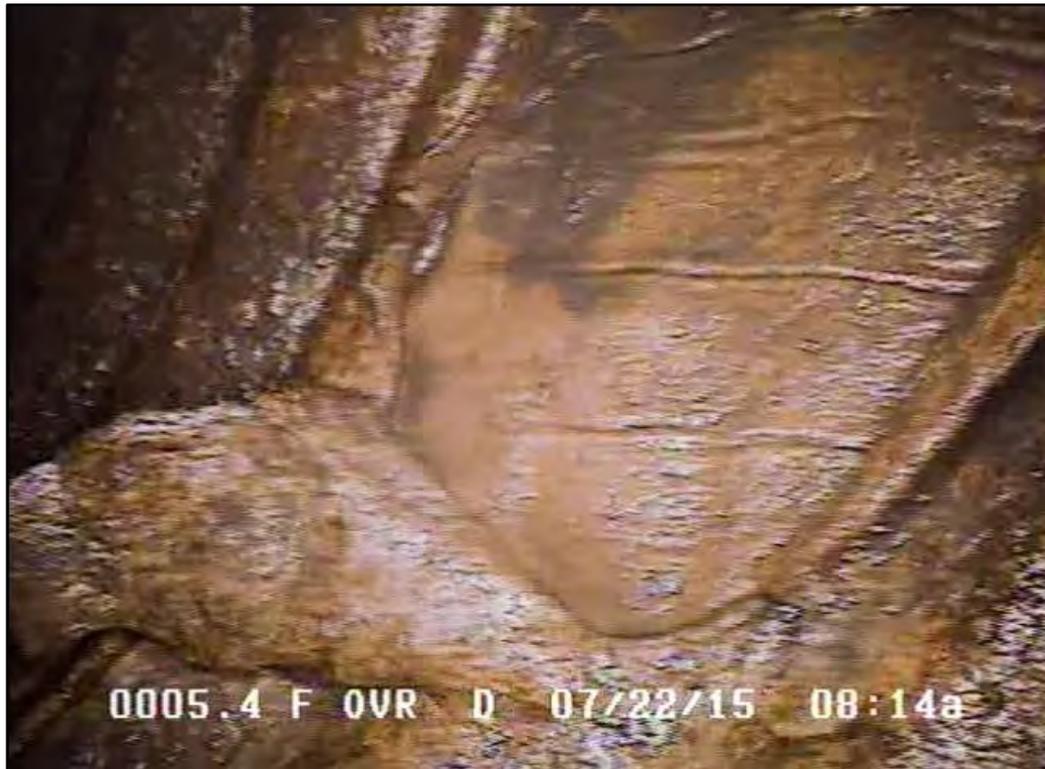
Figure 3.17 - Area F: Break in CMP (Culvert #163A - #163B)

Area F is located along Paul McClure Court (Figure 3.16). CCTV inspection was performed on two culverts in this area with an identified deficiency noted in one of them. The culvert between structures #163A and #163B was broken at several locations and showed signs of rust and root intrusion (see Figure 3.17). The recommended improvement for this culvert is to replace the existing 18” CMP with a new 18” RCP. The estimated construction cost for this area is \$9,800. A detailed breakdown of the cost estimate is included in Table 3.6.

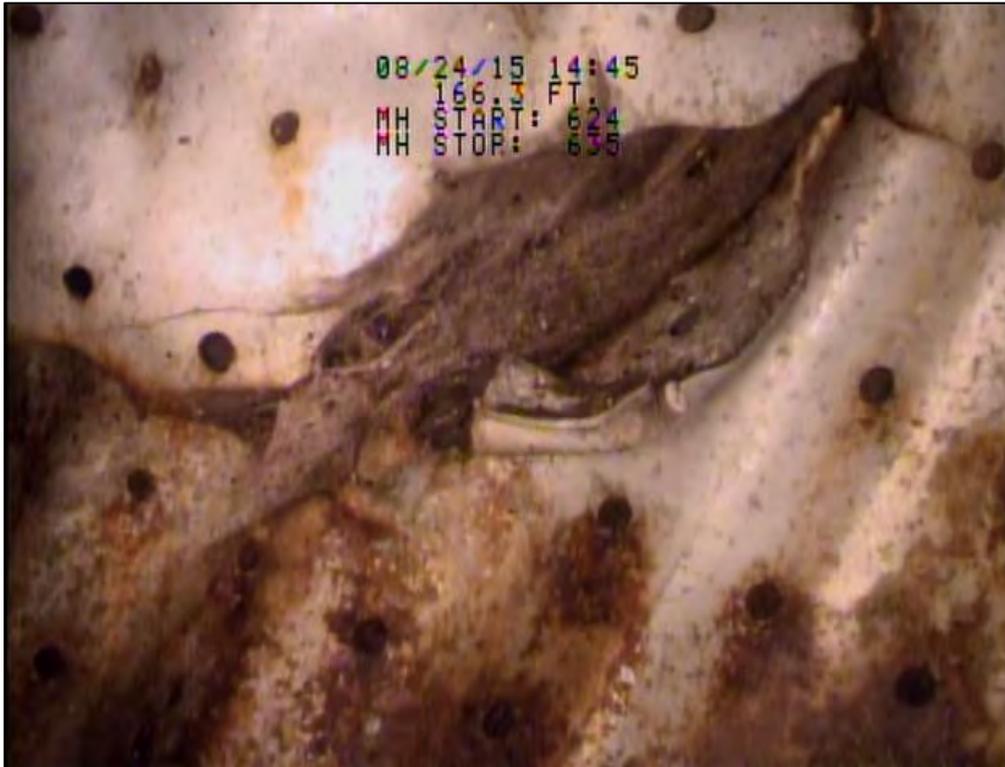
Figure 3.19 - Area G: Crack in CMP (Culvert #624 - #635)

Area G is located along Stanhope Drive (**Figure 3.18**). This area consists of 6 culverts that were inspected by Altair. Deficiencies were identified in 5 of the culverts. The majority of the issues were related to mineral stains which are indicative of leakage. Mineral stains were observed in 3 of the culverts inspected. In addition, infiltration was observed inside the structure walls at inlet #635. Heavy sedimentation was also noted in several culverts, including the culverts between #152 and #115 and between #624 and #635. This is another symptom that suggest infiltration is occurring within the culvert. Examples of the issues observed are presented in **Figures 3.19** and **3.20**. Recommended improvements for this area include CIPP and chemical grout. The culvert from structure #624 to #635 is also recommended to be removed and chemical grout will be placed inside structure #635 where leakage is occurring within the inlet. Sediment and debris must be removed prior to implementing the CIPP or chemical grout rehabilitation.

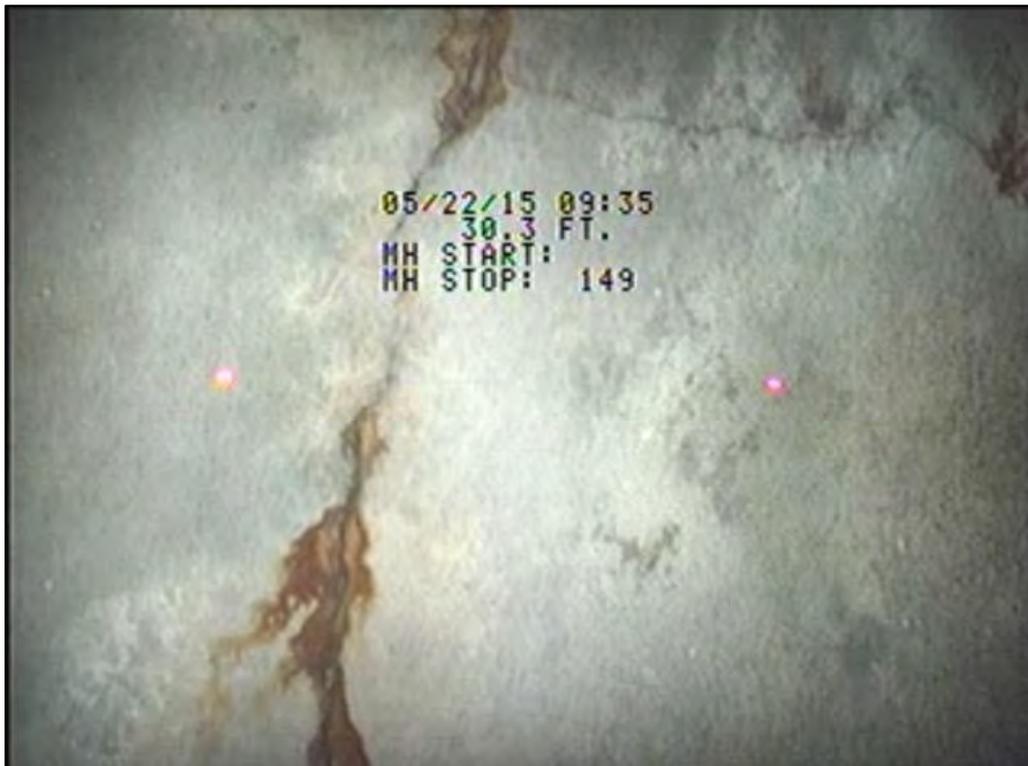
Figure 3.20 - Area G: Crack in CMP (Culvert #648 - #149)

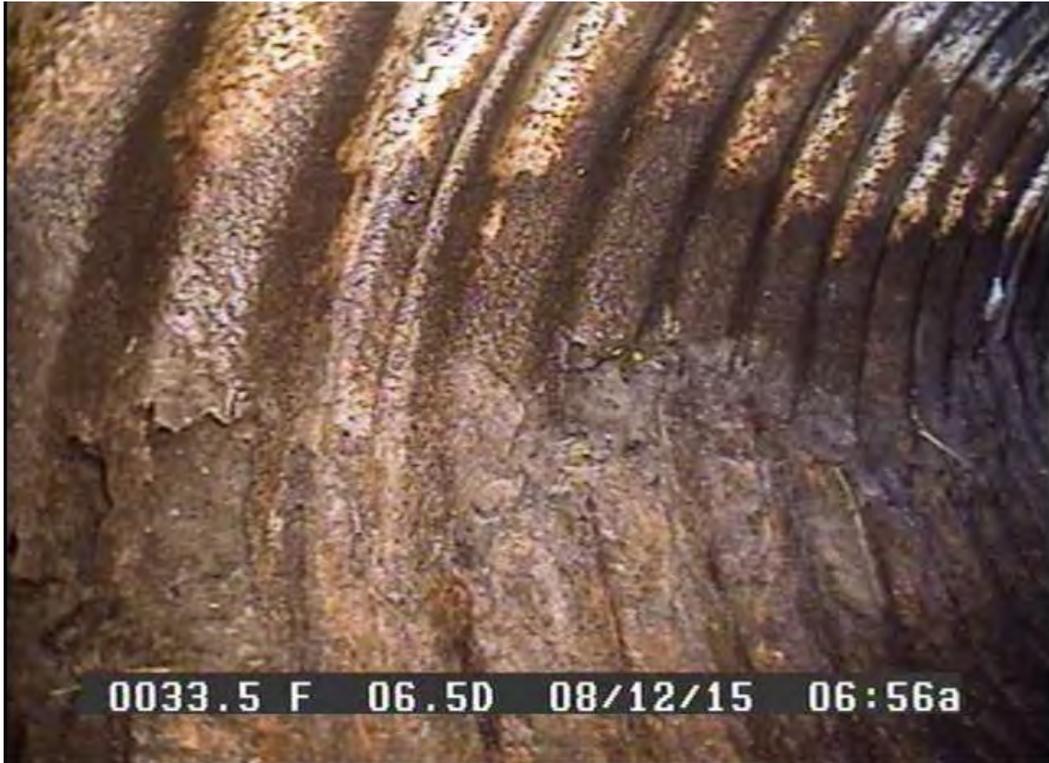
Figure 3.22 - Area H: CMP Deterioration (Culvert #148D - #148E)

Area H is located along Park Avenue (**Figure 3.21**) and is broken down into 3 sub-areas (H1, H2, and H3). CCTV inspection was performed on 8 culverts in this area with only 2 of the culverts requiring rehabilitation. The culvert between structure #148D and #148E at Area H1 near the intersection of Paul McClure Court and Park Avenue is severely rusted and includes a large hole in the pipe with visible soil and filter fabric (**Figure 3.22**). Furthermore, there is a material change in the pipe from CMP to HDPE approximately 15' from the outfall location (**Figure 3.23**). The proposed design for this culvert is to replace it with the equivalent sized (24") RCP.

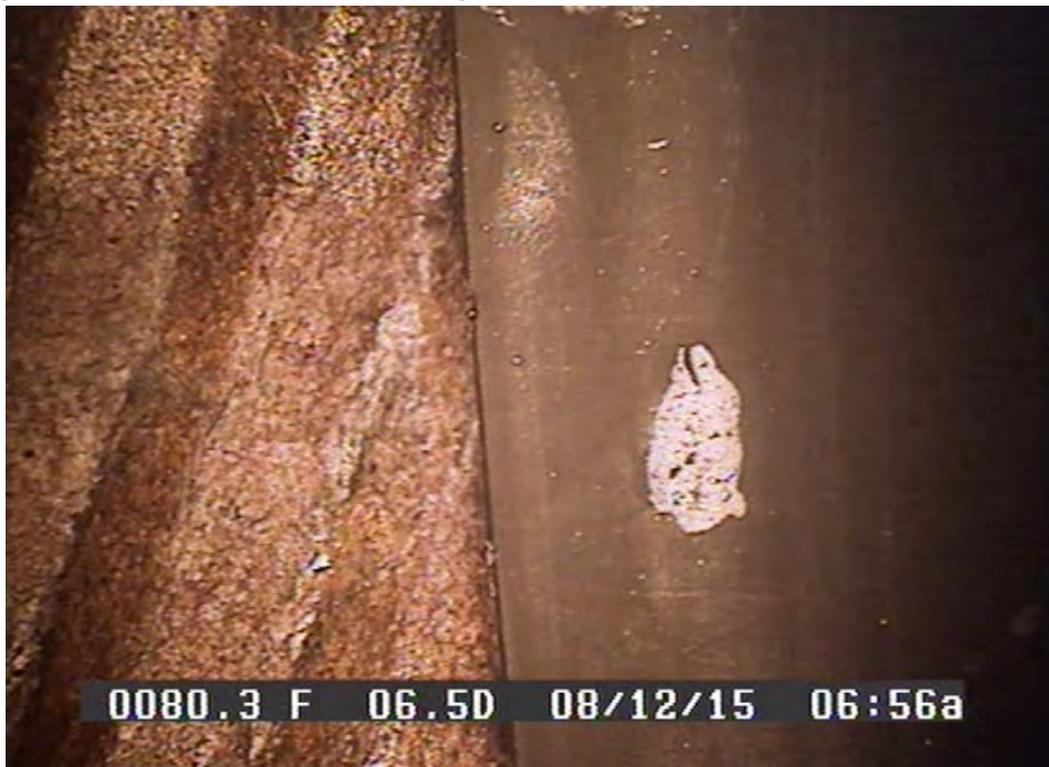
Figure 3.23 - Area H: Material Change from CMP to HDPE (Culvert #148D - #148E)

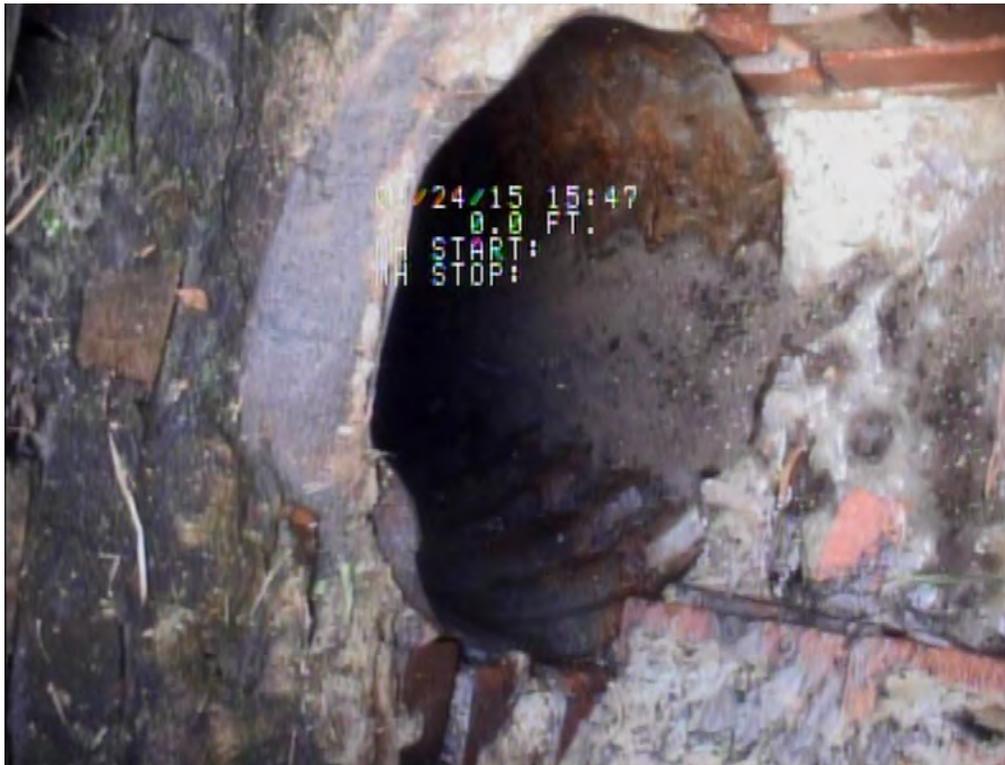
The culvert in Area H3 between #126B and #126A is deformed to where the 18" CMP is bulging in and creates the potential for the pipe to break. The recommended improvement for this area is to replace this existing CMP with an equivalent size (18") RCP. Heavy debris and concrete was also noted in the bottom of structure #126B (**Figure 3.24**).

Figure 3.24 - Area H: Inlet 126B

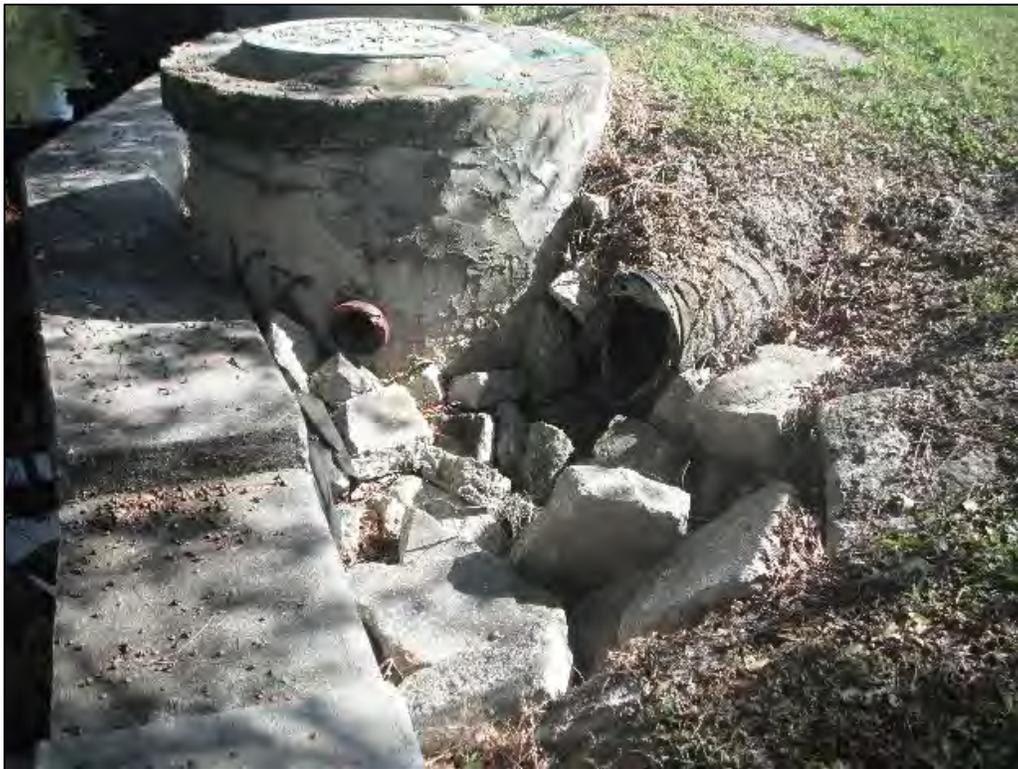
Figure 3.28 - Area K: Erosion Behind Wall (southwest corner)

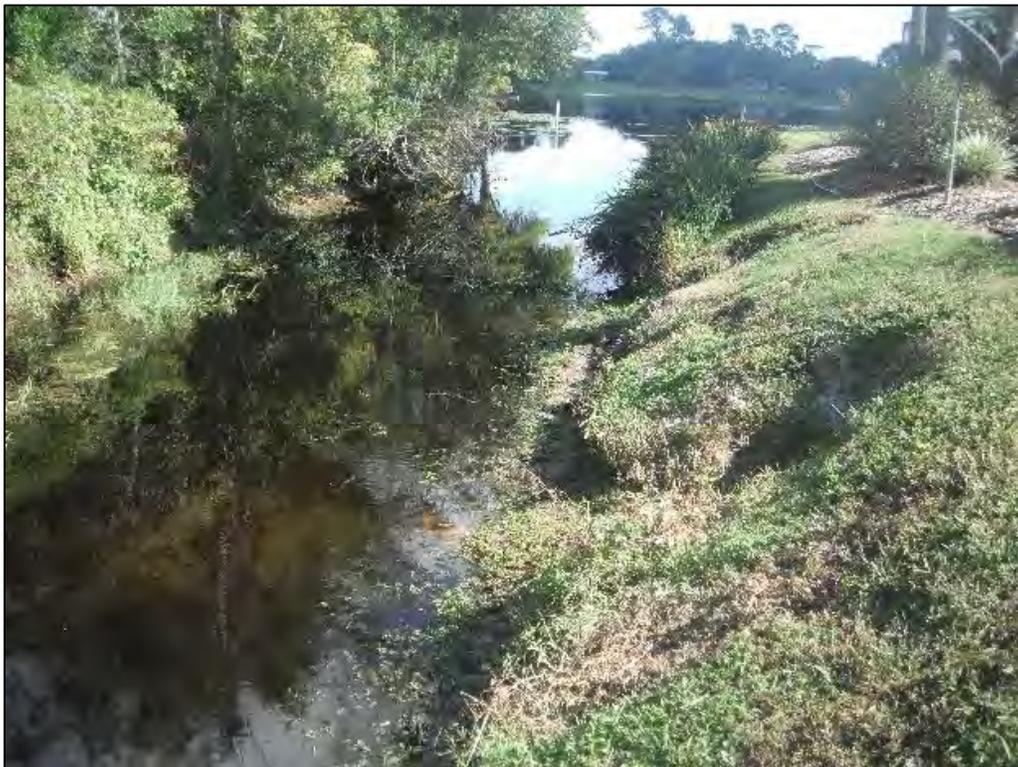
Figure 3.29 - Area K: Ditch Side Slope Erosion (facing southeast)

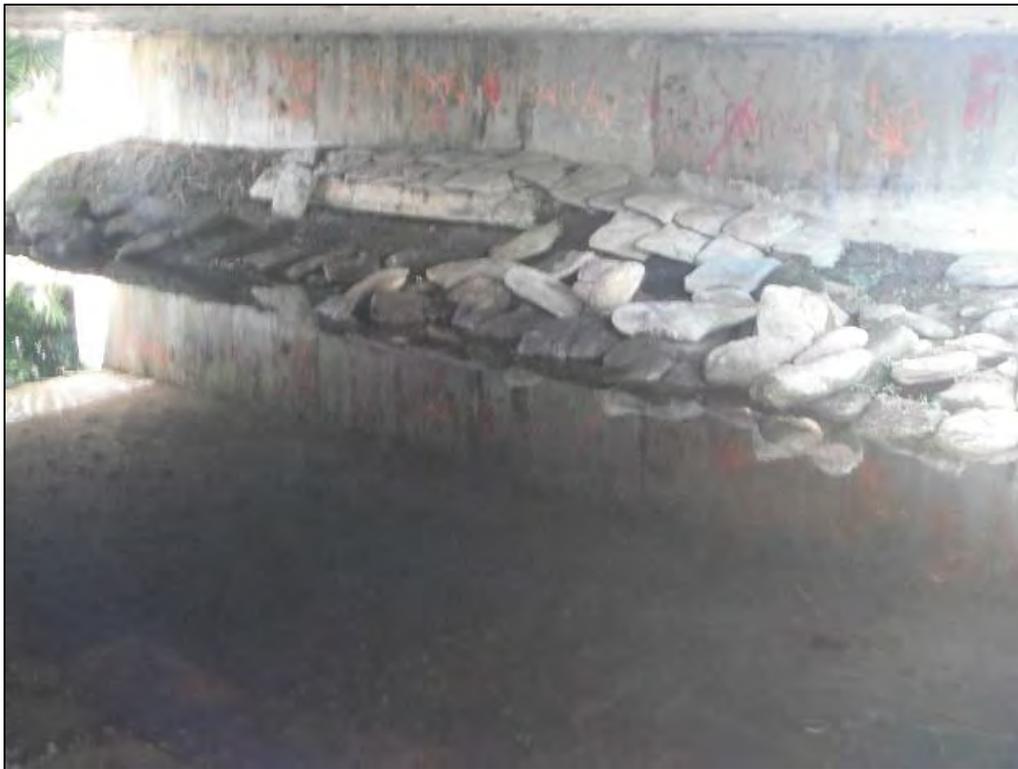
Figure 3.30 - Area K: Underneath Bridge

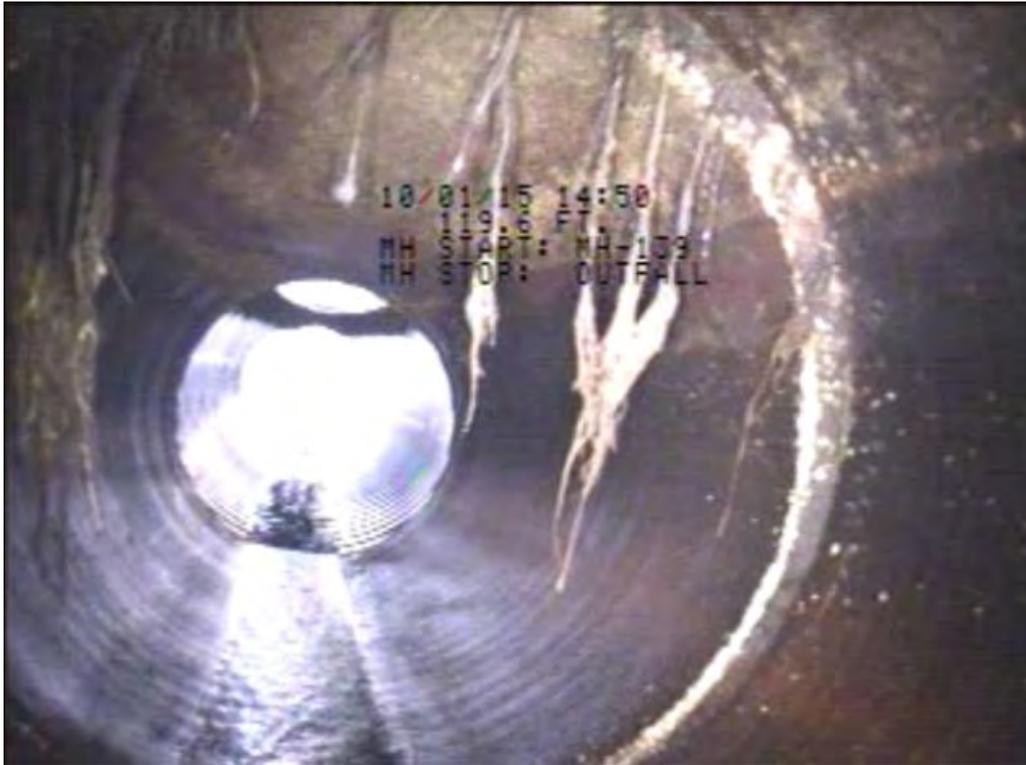
10/01/15 14:50
119.0 FT.
MH START: MH-139
MH STOP: OUTFALL

Figure 3.33 - Area M: Root Intrusion (Culvert #139 - #Outfall)

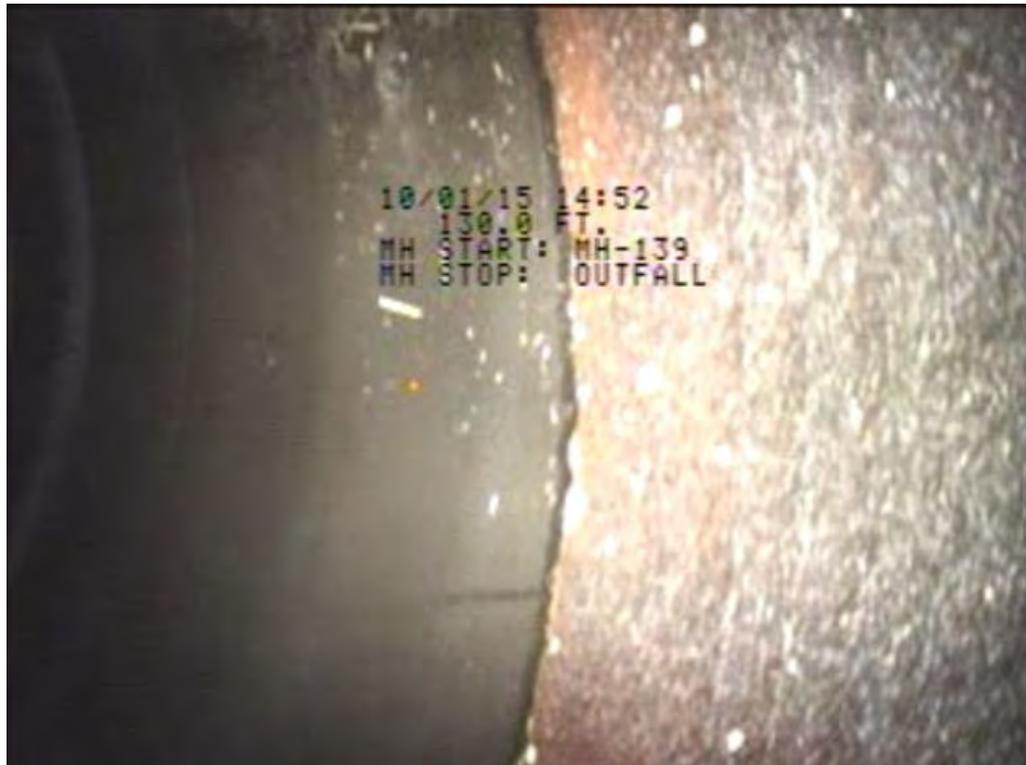
10/01/15 14:52
130.0 FT.
MH START: MH-139
MH STOP: OUTFALL

Figure 3.34 - Area M: Material Change- RCP to ADS (Culvert #139 - #Outfall)

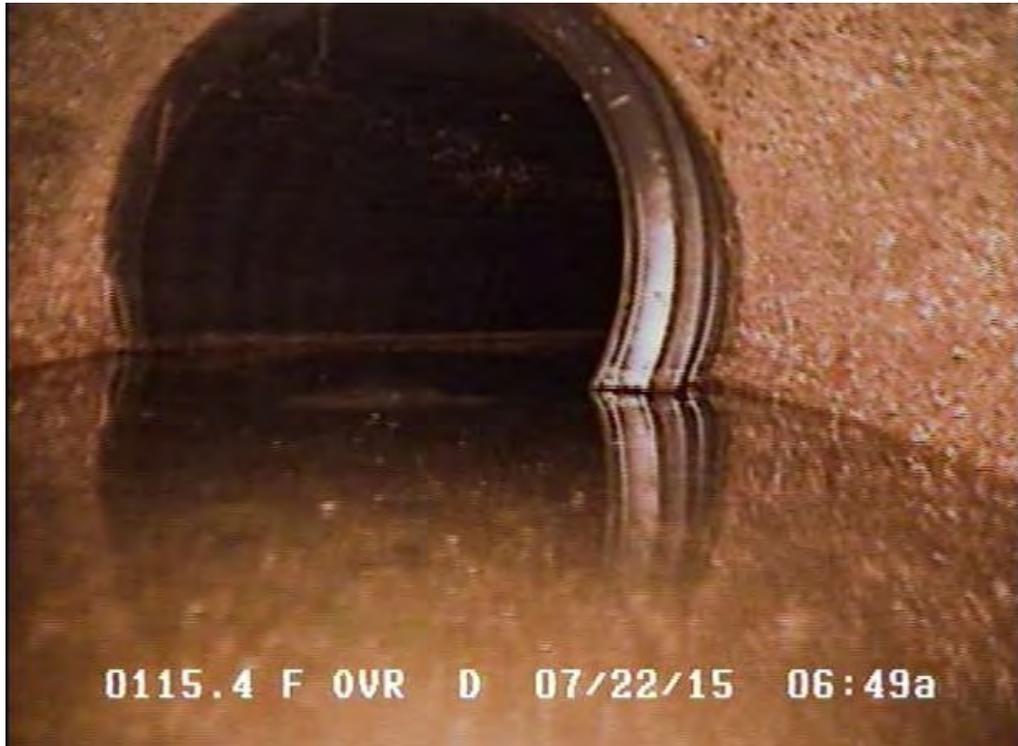
Figure 3.37 - Area O: Material Change – RCP to ADS (Culvert #225 - #225A)

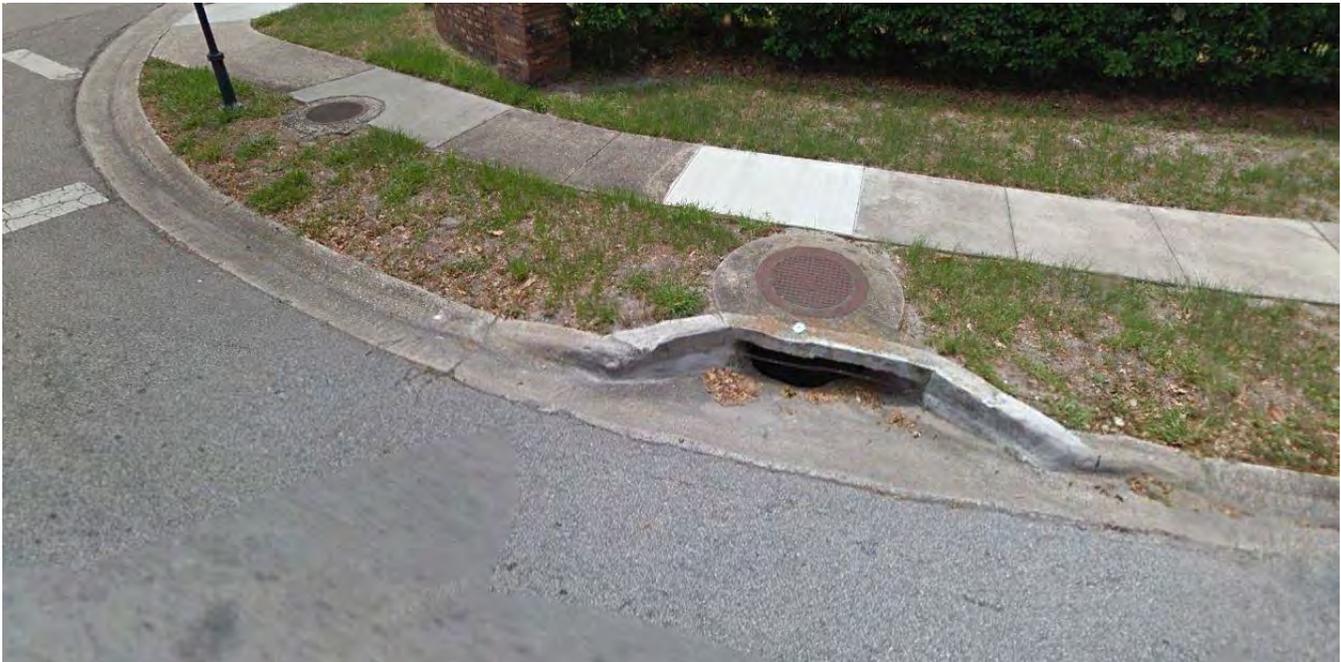
Figure 3.39 - Area P: Raised Curb and Inlet

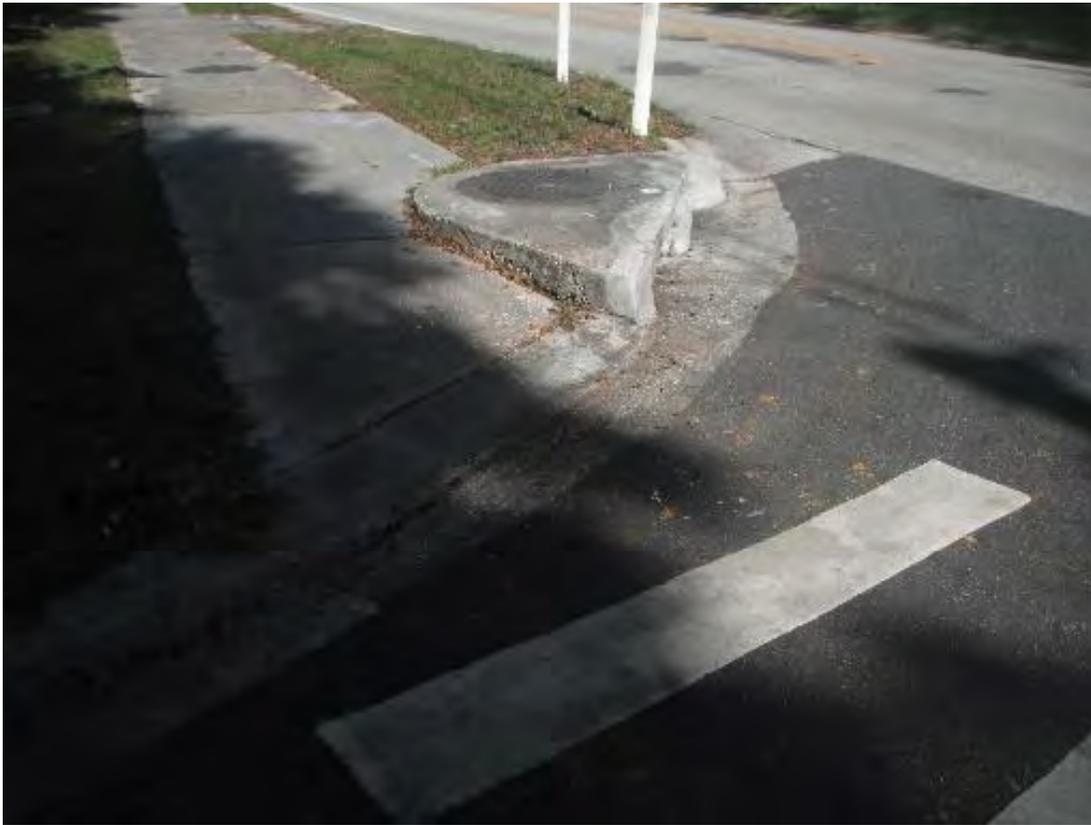
Figure 3.42 - Area R: Raised Inlet at Sidewalk (facing north)
