Storm Drain Rehabilitation Project Corrective Action Plan (CAP) – Final Submittal Technical Memorandum (City Project PW 1501-2015)

City of Casselberry, FL

Singhofen & Associates, Inc.
Stormwater Management and Civil Engineering

June 2016

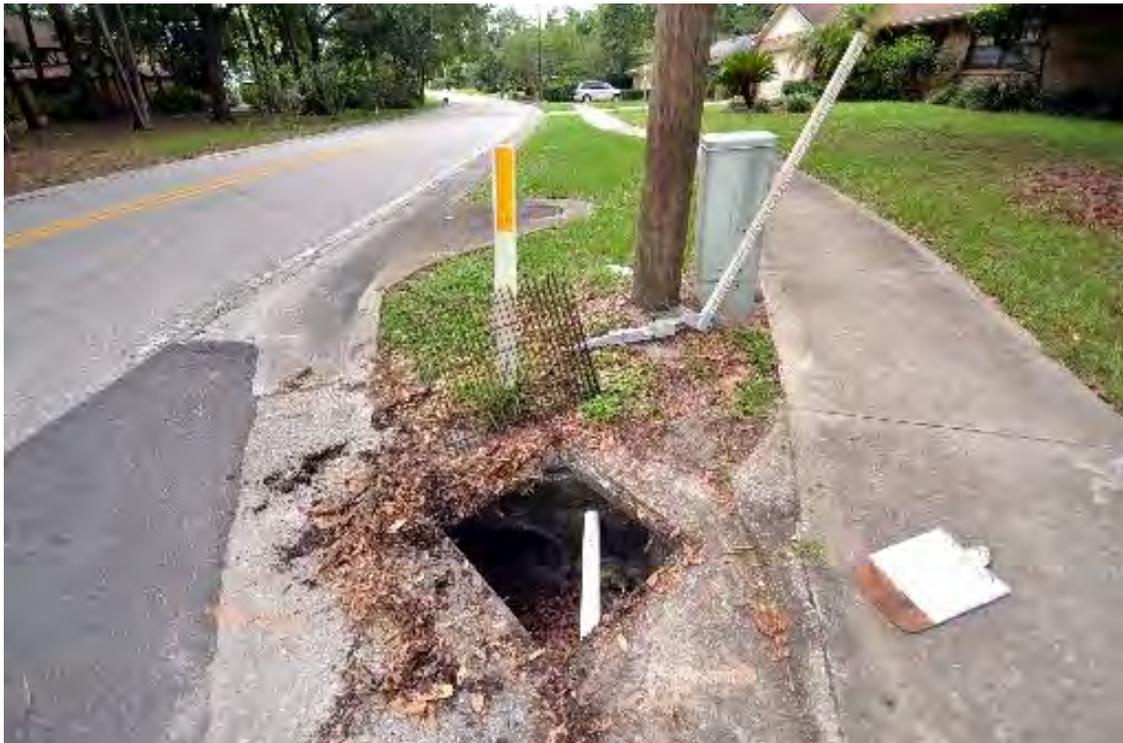
Figure 3.43 - Area R: Inlet and Pipe Conflict (facing south)

Another option that was evaluated included removing the existing ditch bottom inlet structure and re-grading the intersection to drain to the adjacent curb inlet. However, there are multiple utilities in this area including a 3" PVC pipe that runs through the existing structure. **Figure 3.43** includes a photograph of the inlet and the PVC conflict. The degree of difficulty for the contractor to remove this structure without impacting existing utilities and other pipes would be high; thus this option is not recommended.

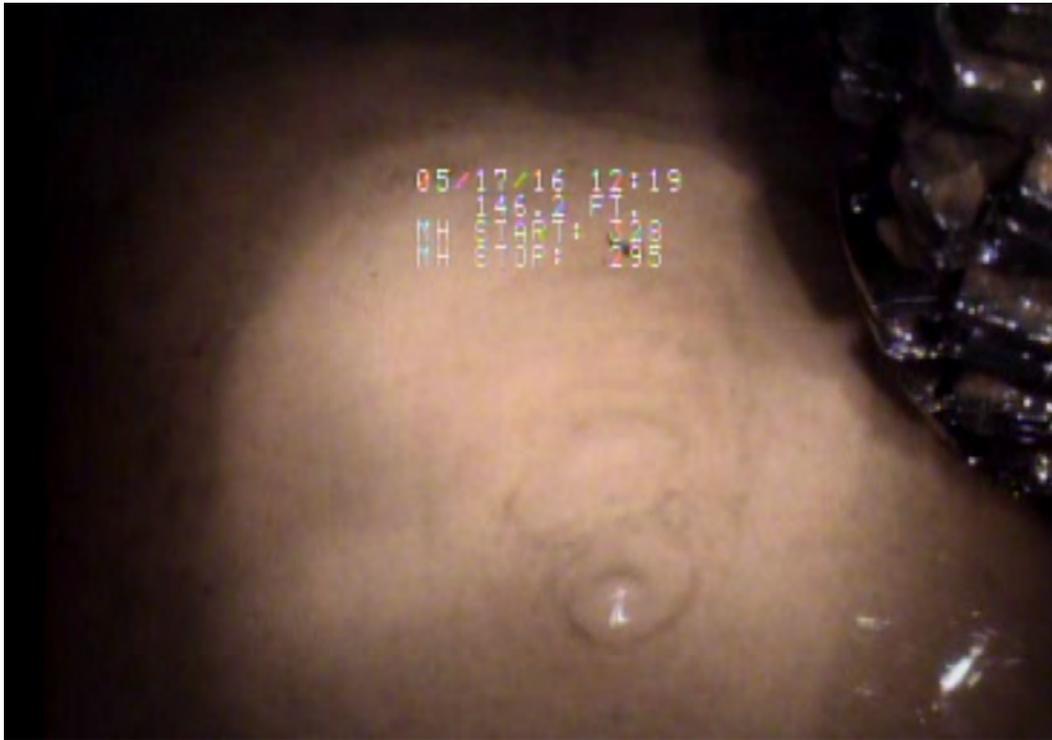
Figure 3.45 - Area S: Water and Sand Infiltration at Joint

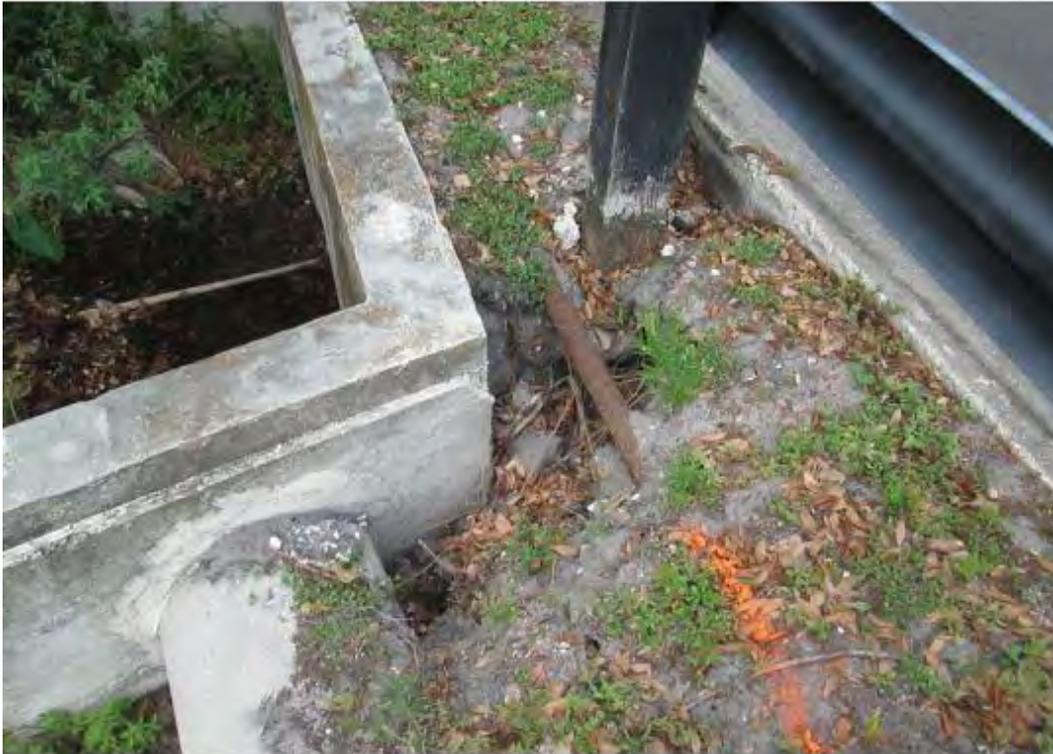
Figure 3.48 - Area U: Erosion Behind Wall (facing north)

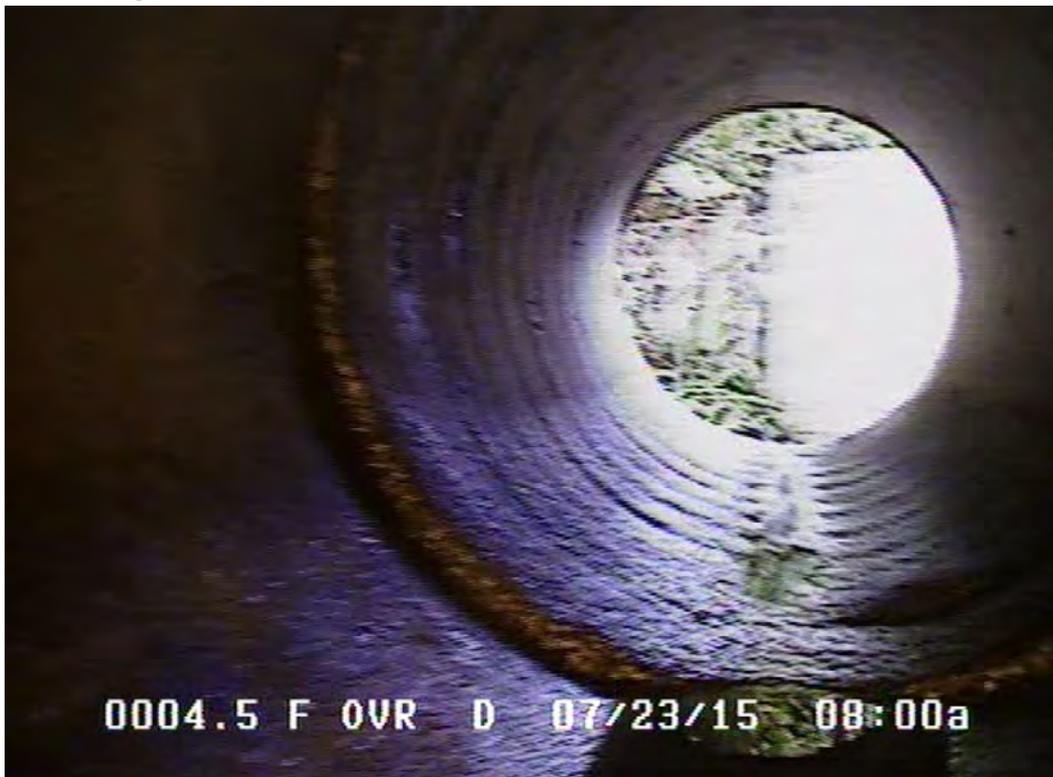
Figure 3.49 - Area U: Separation at Joint (Culvert #MH1 – #1A)

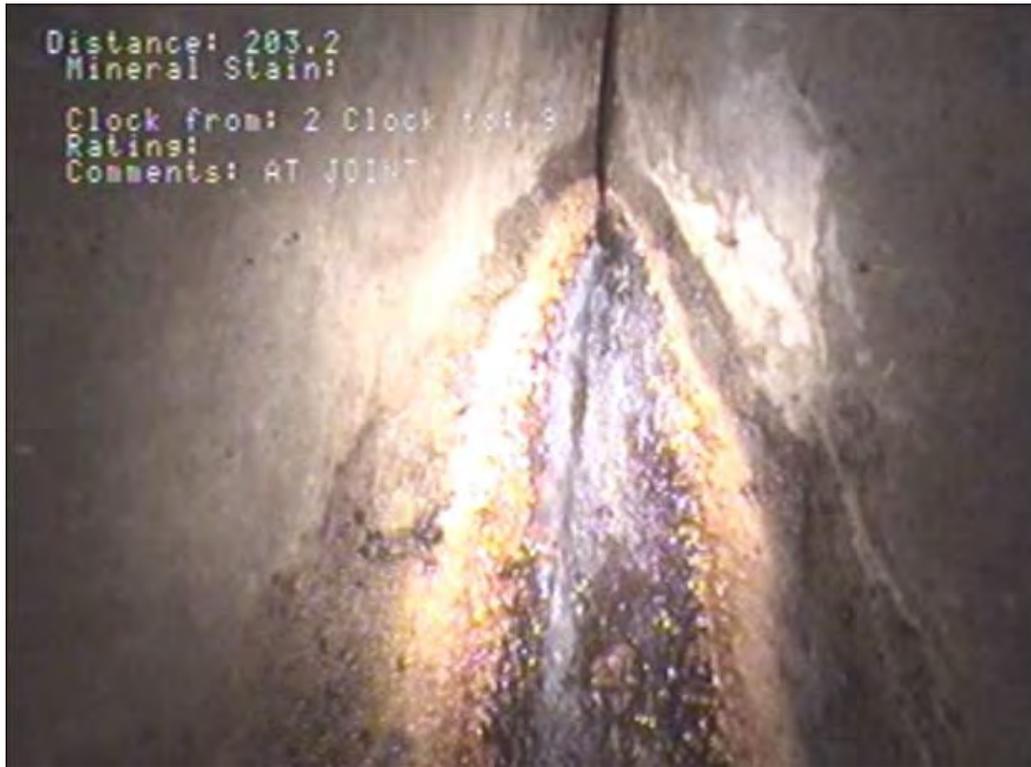
Figure 3.51 - Area V: Mineral Stain at Joint (Culvert #1166 - #1166A)
