City of Casselberry & Florida Fish & Wildlife Conservation Commission

Lake Griffin Workshop

Lake Griffin

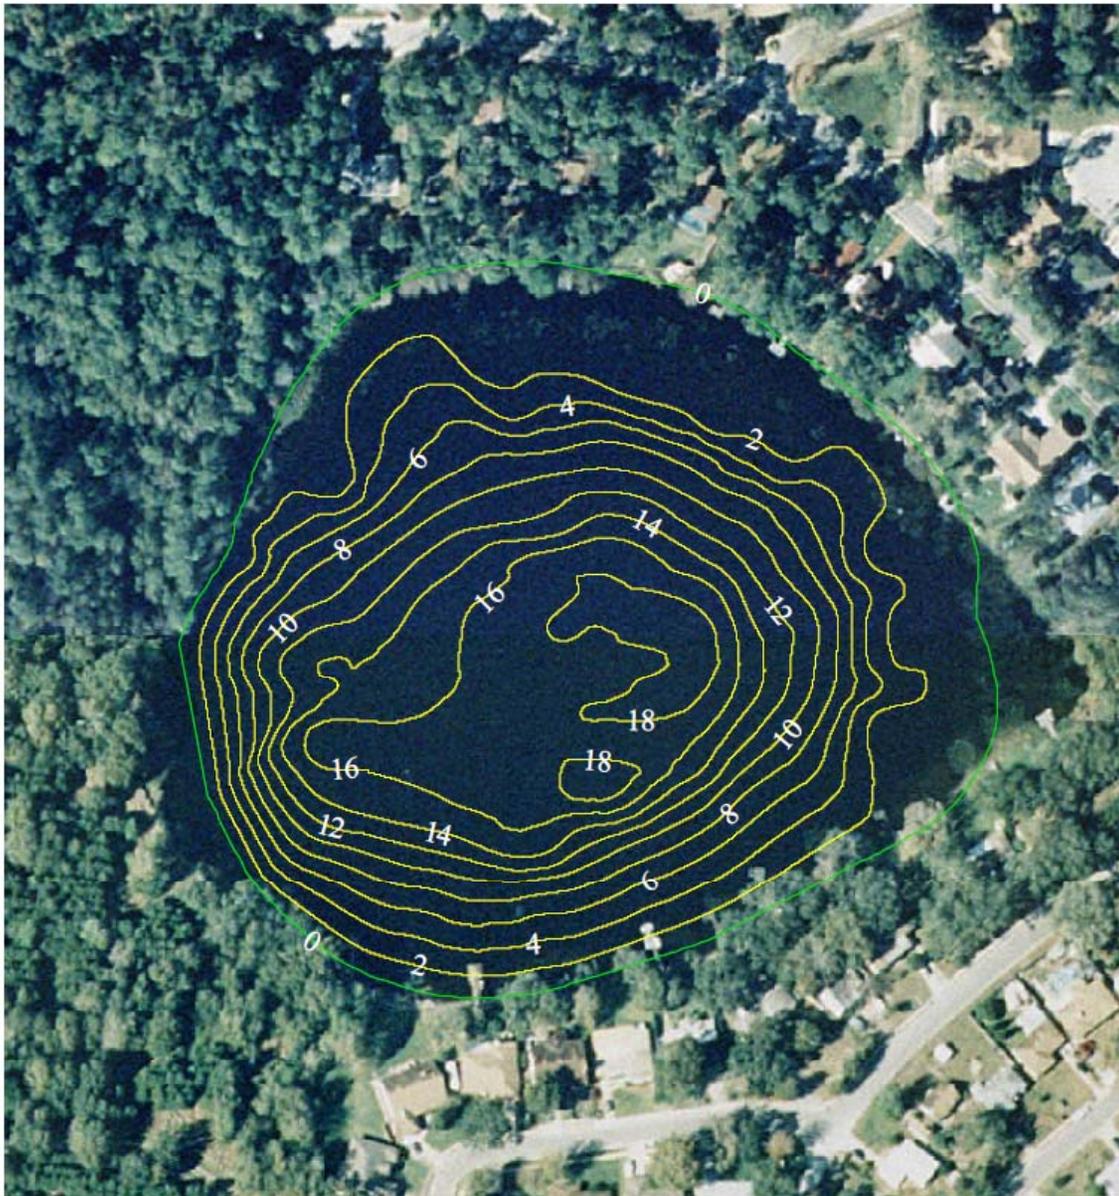
Lake Griffin

Contour Lines
Expressed in
2-Foot Intervals

Estimated Lake
Perimeter

Assessment Date: July 7, 2002.
Lake water level was **72.378 ft.**
above sea level when the lake was
assessed. Contours are expressed in
absolute depth below this level and
may not exclude the presence of
submersed aquatic vegetation.

Seminole County 1999 color aerials
provided by Seminole County Public
Works. All contours generated by
Florida Center for Community Design
and Research based on GPS/Sonar
data provided by the Seminole County
Stormwater Division.

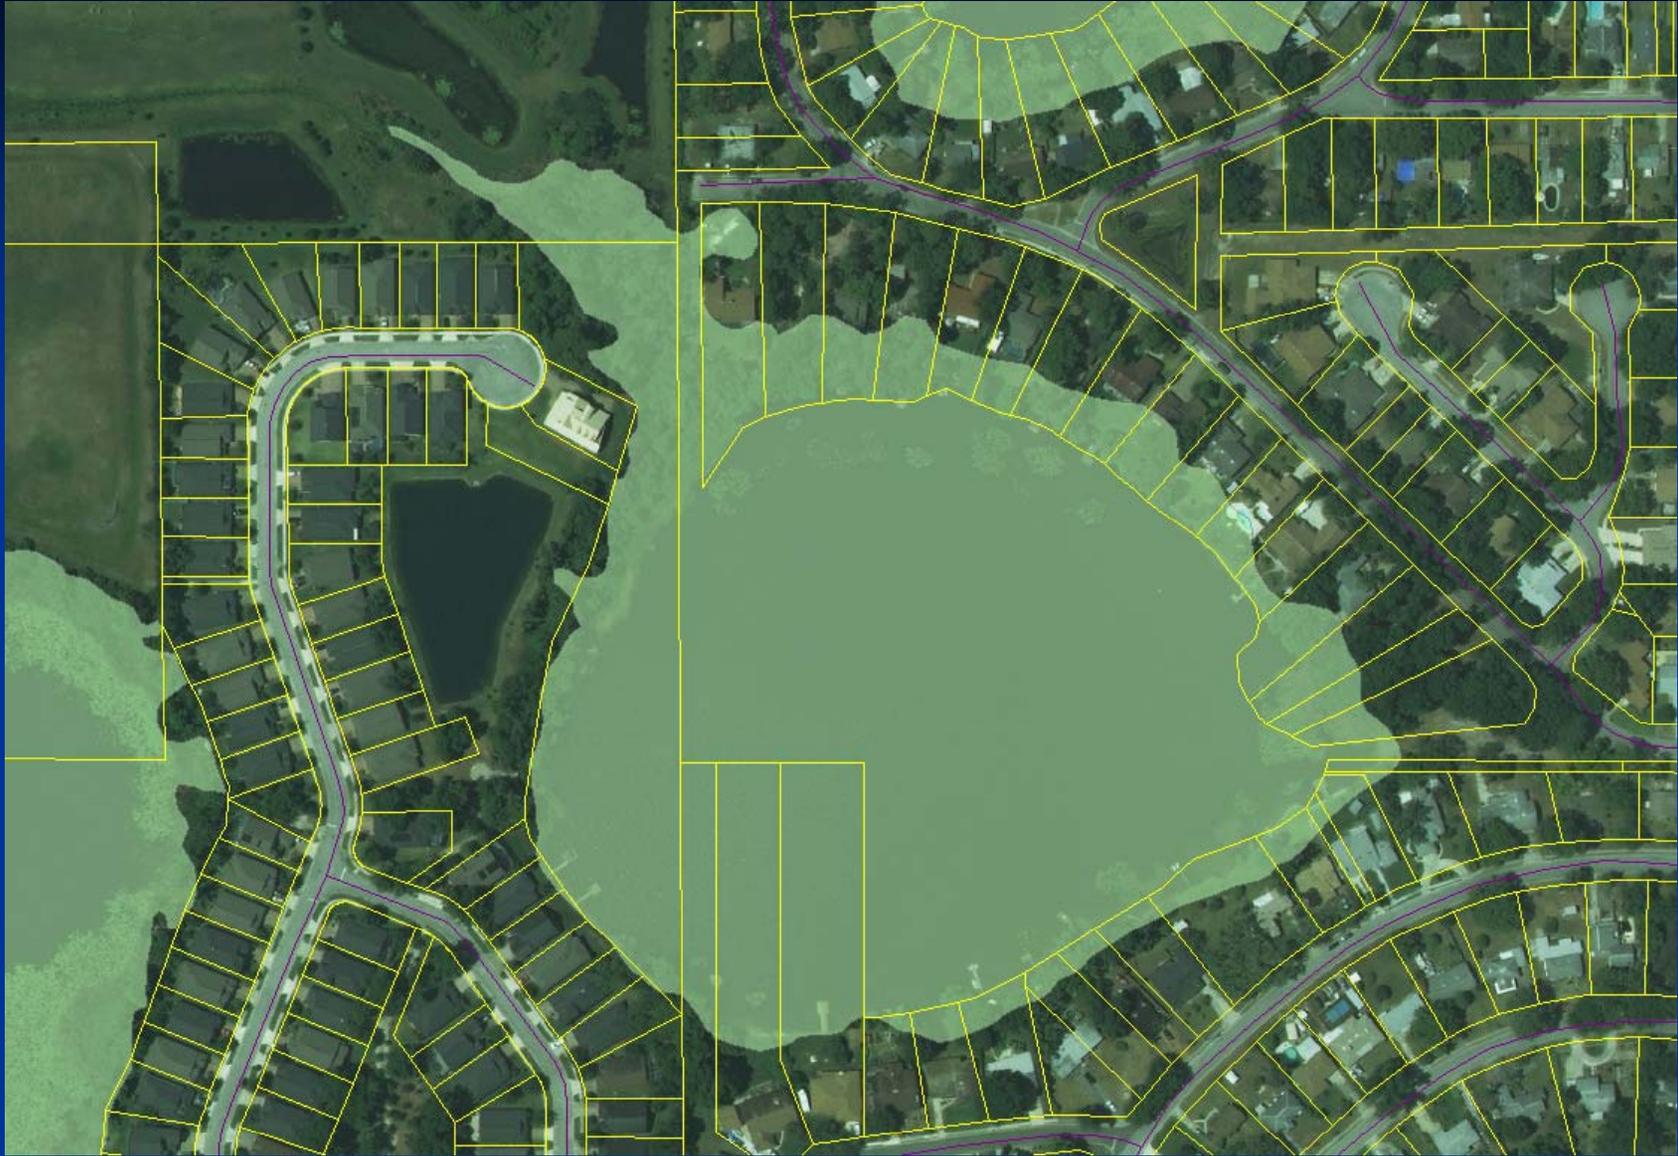
- Approximately 14 acres
- Depths up to 18 feet
- 100 year flood elevation 76.6 ft

100 year floodplain

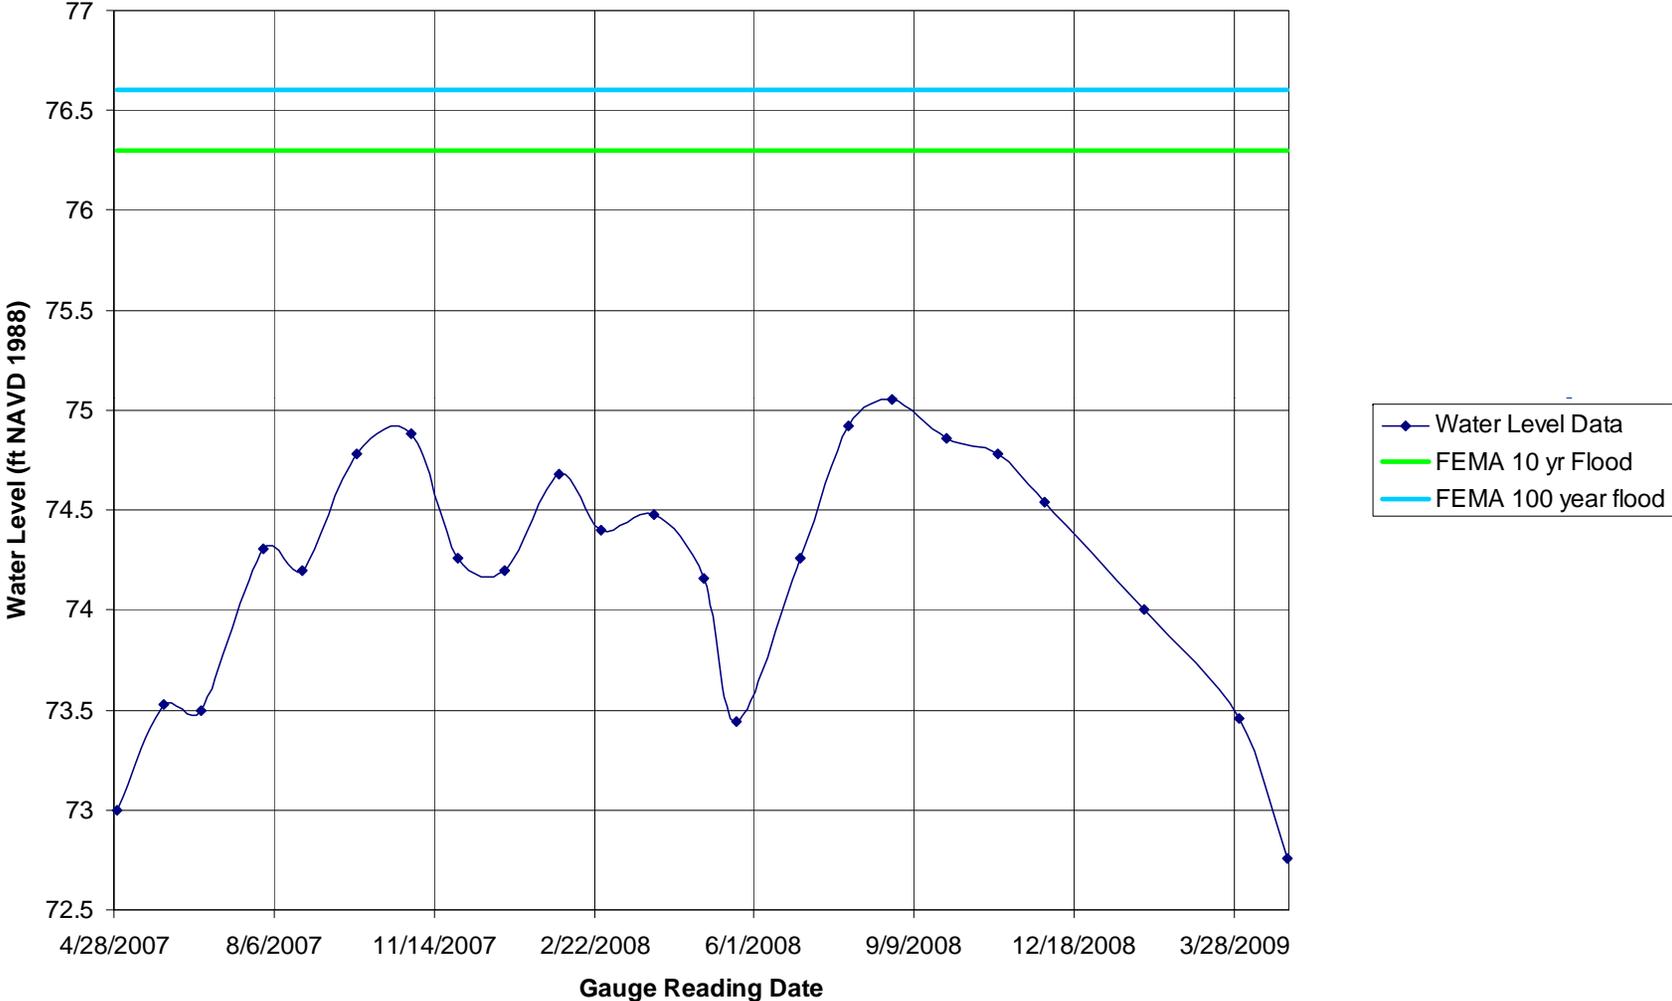
Lake Griffin Water Levels

- Approximately 14 acres
- Depths up to 18 feet
- 100 year flood elevation 76.6 ft
- Part of the Gee Creek Basin (Lake Jesup Watershed)
- Water elevation typically 73-75 ft

Water surface elevation

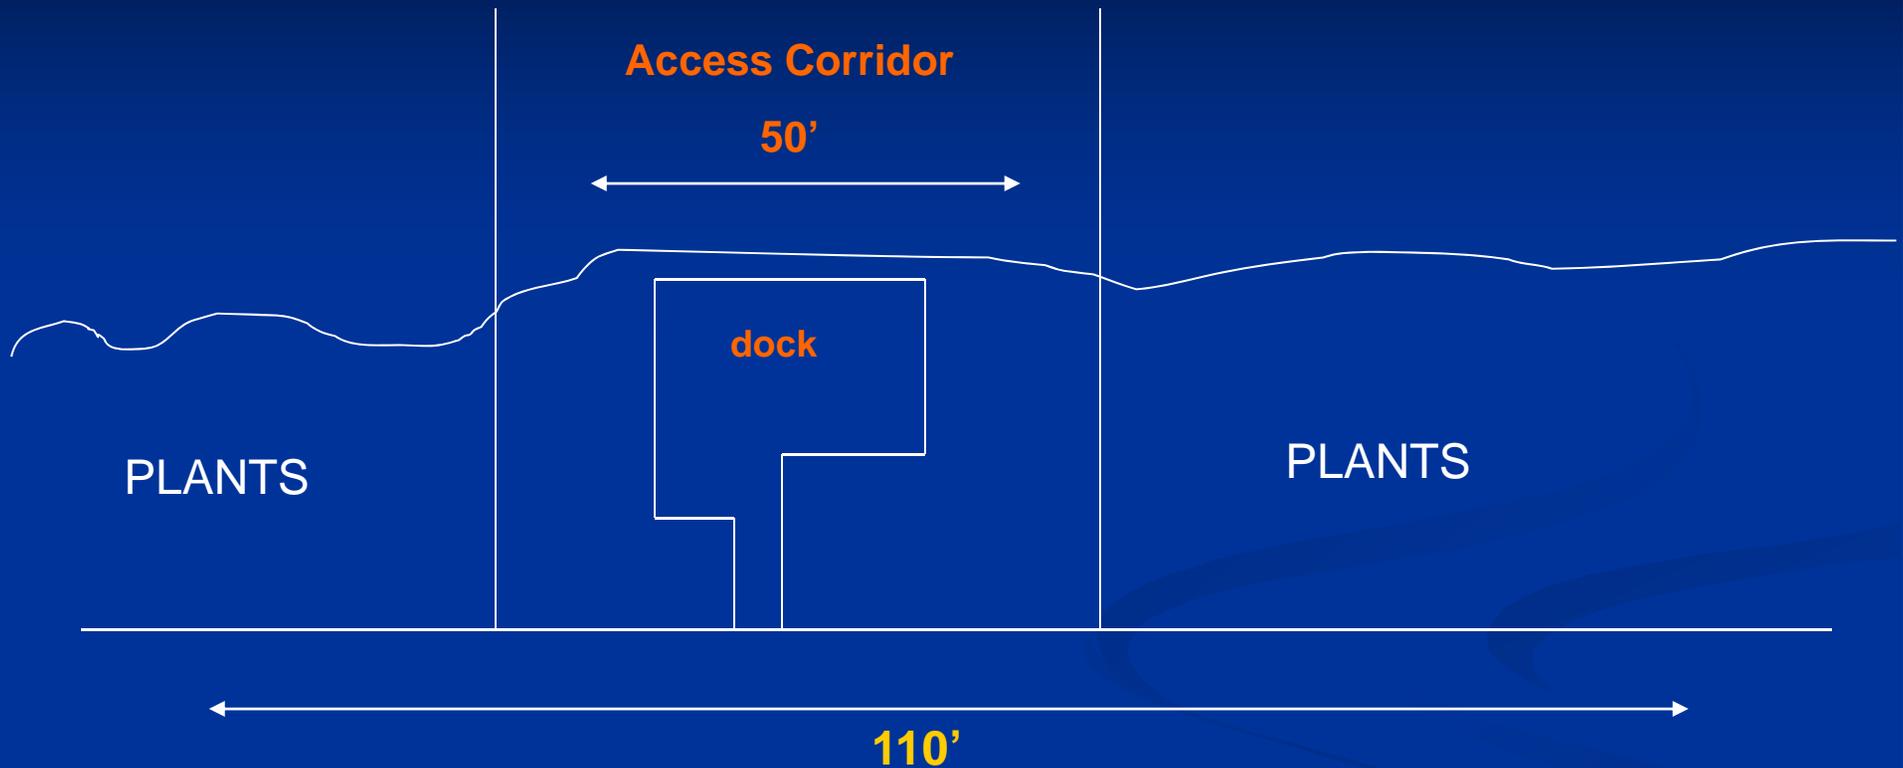
FWC Aquatic Plant Management Permit

- Can clear 50', or 50%, whichever is less
- Rest of lakefront **MUST** be vegetated with submersed and emergent plants
- Either plant native aquatic plants, or let what was there regrow (“something is better than nothing”)
